STANDARD OPERATING PROCEDURE

Working on or Around OTR Equipment with Damaged or Low Pressure Tires

Document Number: 960C-SOP-829

Appendix A Tire Damage – Risk of Tire Failure Guideline

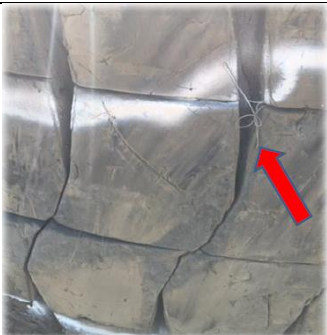
LOCATIO N	DAMAGE DESCRIPTION	PICTURE	RISK OF FAILURE	ACTIONS
TREAD	Tread separation with visual deformation of casing

Medium to High	Notify supervision or tire technician. Competent person to deflate to 10 psi.
	Tread cut separation, three lugs or less.	No picture.	Medium	Notify supervision or tire technician for further inspection.
	Tread cut separation, four lugs and more.	No picture.	Medium to High	Notify supervision or tire technician. Competent person to deflate to 10 psi.
	Tread lug missing, no visible steel (cosmetic).

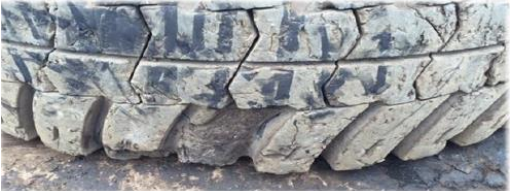
Low	No action, tire is safe to work around.
	Tread lug missing, visible steel no cords broken.

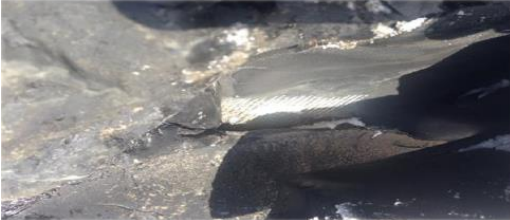
Medium	Notify supervision or tire technician for further inspection.

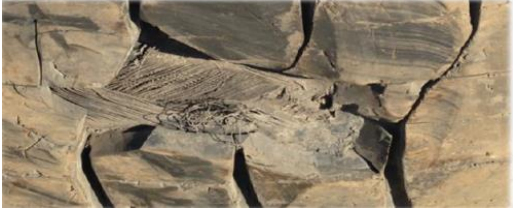
TREAD	Tread lug missing, visible steel cords broken, second layer exposed 12 inches in length or greater.

Medium to High	Notify supervision or tire technician. Competent person to deflate to 10 psi.
	"Puffer"	No Picture. Damage may not always be visible and may present itself as a "puffer" or rapid loss of air with each tire revolution.	Medium	Notify supervision or tire technician for further inspection.
LOCATIO N	DAMAGE DESCRIPTION	PICTURE	RISK OF FAILURE	ACTIONS
SIDEWALL	Sidewall bulge in any area.

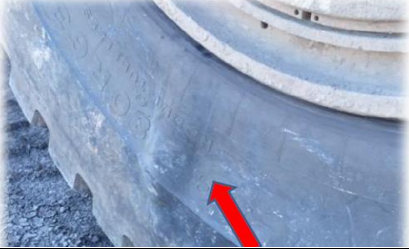
Medium to High	Notify supervision or tire technician. Competent person to deflate to 10 psi.
	Cut reaching any visible sign of casing ply cable exposure (steel visible).

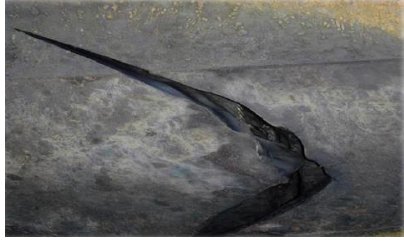
Medium to High	Notify supervision or tire technician. Competent person to deflate to 10 psi.
	Cut clusture (spider cuts) no cords visible in turn up area.

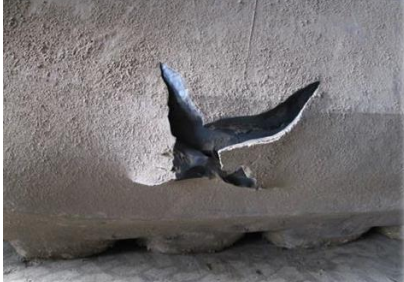
Medium	Notify supervision or tire technician for further inspection.

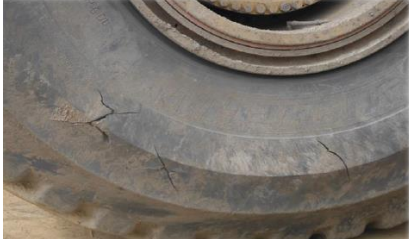
SIDEWALL	Cut clusture (spider cuts) no cords visible NOT in turn up area.

Low	No action, tire is safe to work around.
	Cut migrating to the flange and bead area (steel visible).	No picture.	Medium to High	Notify supervision or tire technician. Competent person to deflate to 10 psi.
	Cut migrating to the flange and bead area (NO steel visible).	No picture.	Medium	Notify supervision or tire technician for further inspection.
	Cut breaching the casing ply cables.	No picture.	Medium to High	Notify supervision or tire technician. Competent person to deflate to 10 psi.
LOCATION	DAMAGE DESCRIPTION	PICTURE	RISK OF FAILURE	ACTIONS
SIDEWALL	Sidewall turn up separation if larger than two (2) inches.

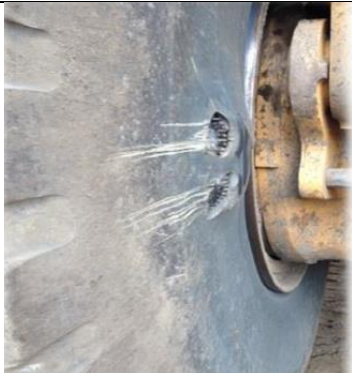
Medium to High	Notify supervision or tire technician. Competent person to deflate to 10 psi.

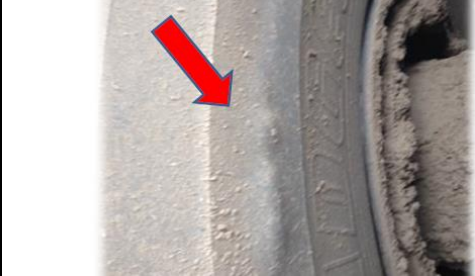
SIDEWALL	Sidewall turn up separation if SMALLER than two (2) inches.

Medium	Notify supervision or tire technician for further inspection.
SIDEWALL	Cut five (5) inches plus.
